## MultoLag™ Direct Bond Ceramic Pulley Lagging

# Multolag™ Direct Bond Ceramic Pulley Lagging

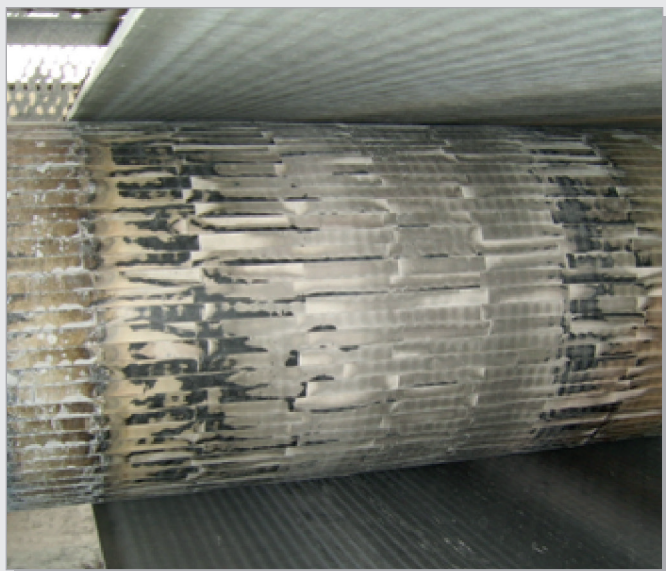
Multolag™ Non-Drive Pulley Lagging after more than fifteen years in operation

- Work polished smooth ceramic tiles reduce friction and therefore wear on both the pulley and conveyor belt

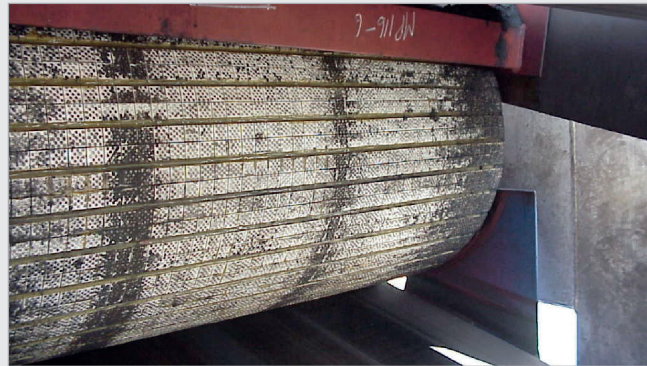
Multolag™ Drive Pulley Lagging after more than five years in operation

- High density ceramic tiles with studs maintain maximum traction in all, including wet and muddy, conditions
- Studs with rounded edges prevent belt undercover wear
- Dewatering grooves dissipate water and dirt
- Drive pulleys can be hosed down without losing traction
