## MultoLag™ Direct Bond Ceramic Pulley Lagging

# Multolag™ Direct Bond Ceramic Pulley Lagging

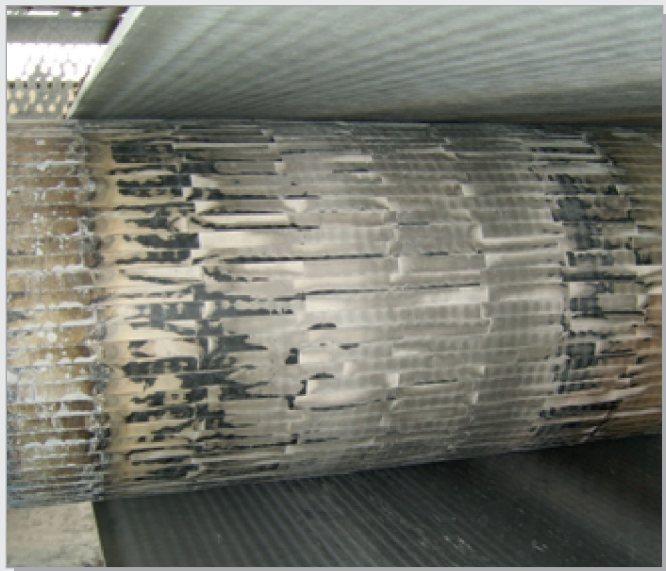
Multolag™ Non-Drive Pulley Lagging after more than fifteen years in operation

- Work polished smooth ceramic tiles reduce friction and therefore wear on both the pulley and conveyor belt

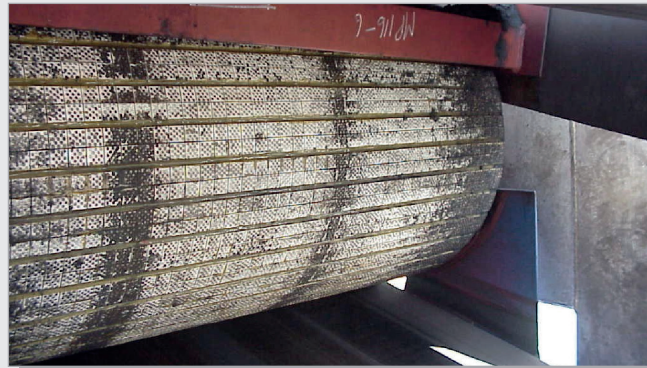
Multolag™ Drive Pulley Lagging after more than five years in operation

- High density ceramic tiles with studs maintain maximum traction in all, including wet and muddy, conditions
- Studs with rounded edges prevent belt undercover wear
- Dewatering grooves dissipate water and dirt
- Drive pulleys can be hosed down without losing traction

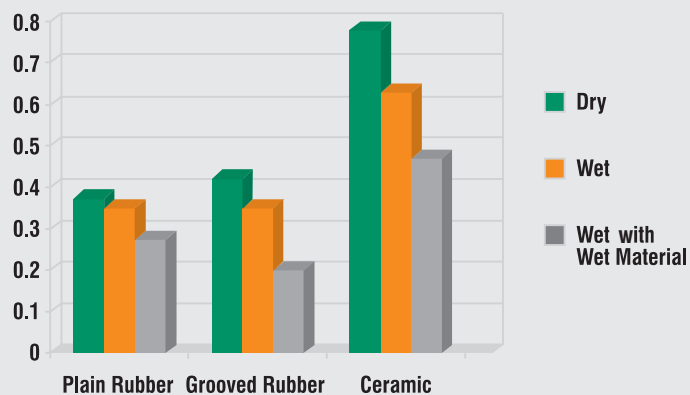
## Coefficient of Friction Graph for Drive Pulley Lagging
